**NWCG Equipment Technology Committee
Invasive Species Subcommittee**

Equipment Bulletin

ETC-EB-2016-03

Subject: Engine and Water Tender Foot Valve Leakage – Field Test Protocol

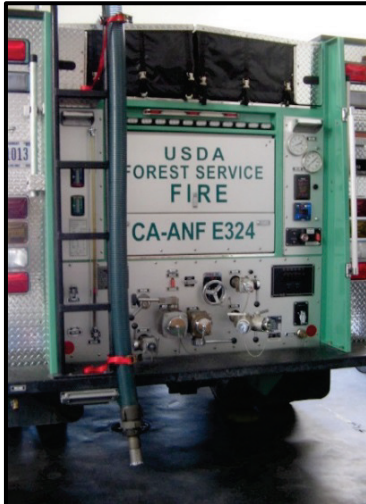
Figure 1. Suction hose with foot valve attached to engine ladder.

Fasten the suction hose vertically to the engine or water tender (Figure 1). Use ratchet straps or another suitable method, as long as the suction hose is attached safely and securely.

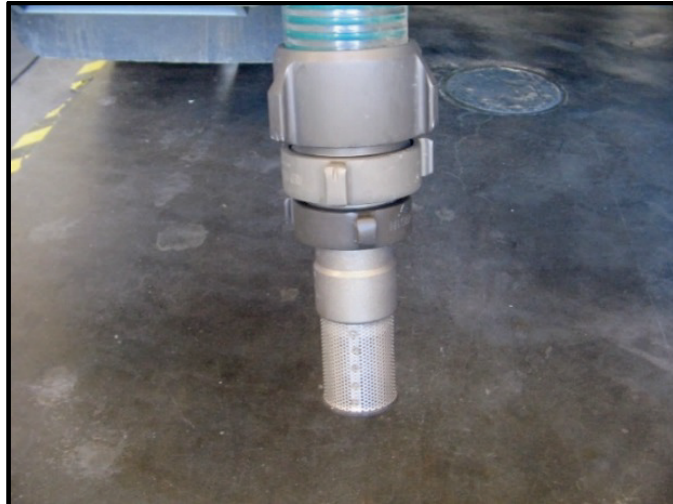
Figure 2. Foot valve attached to suction line with various adapters as needed to adjust for foot valve size.

To adjust for size of the foot valve (e.g., 1½", 3" or other), use a combination of male-to-female adapters, increasers, and/or reducers to attach the foot valve to the suction hose (Figure 2). Fill the suction hose with six to 10 feet of water to obtain 3-5 psi (i.e. 2' hose = 1 psi). The weight of the water provides the pressure on the foot valve. Check the foot valve for 3 to 5 minutes. There should be no leakage. If leakage occurs, replace the foot valve with one that does not leak.

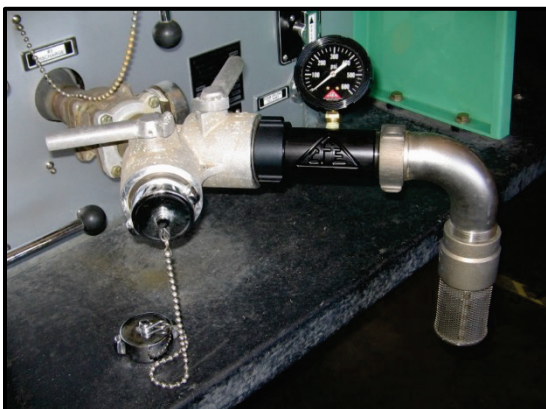
Figure 3. Pressure valve attached to the foot valve.

To perform the high pressure test, first attach a wye or other suitable shut-off valve to the rear discharge (Figure 3). If a pressure gauge is not available on the equipment, attach a pressure gauge to the wye, then attach the 90 degree elbow and next attach the foot valve. The test set-up should resemble the one shown in Figure 3. Using the engine's pump, increase the pressure to 130 psi. Check the foot valve for 3 to 5 minutes. There should be no leakage. If leakage occurs, replace the foot valve with one that does not leak.
